Technical Report

NAVAL CIVIL ENGINEERING LABORATORY

# **DETERMINATION OF BLAST LEAKAGE PRESSURES AND FRAGMENT VELOCITY FOR FULLY VENTED AND PARTIALLY VENTED PROTECTIVE CUBICLES**

Technical Report R-780

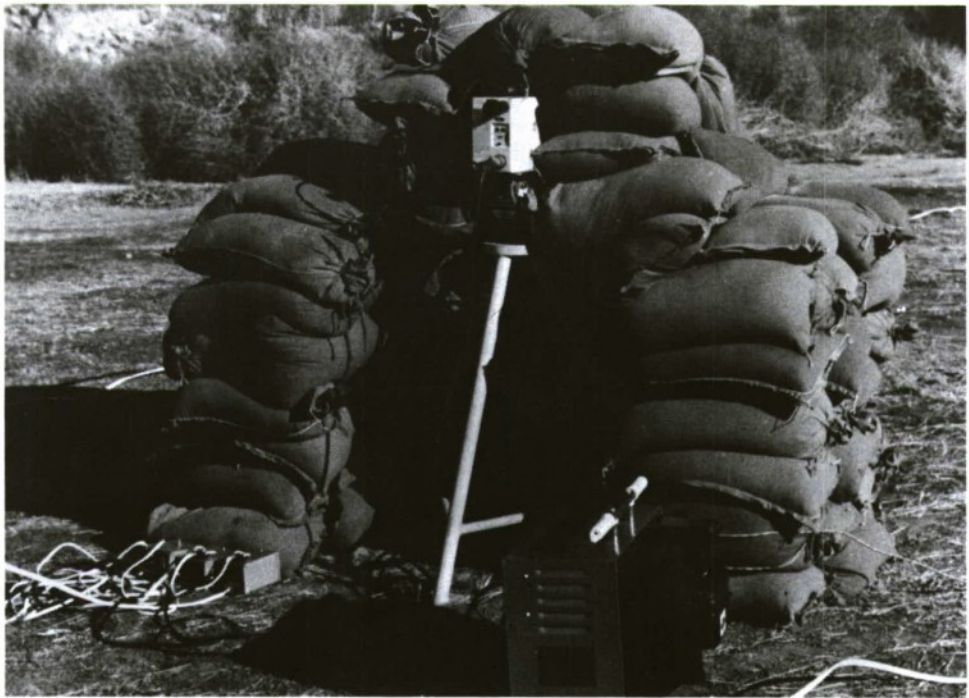
Figure 25. High-speed camera position.

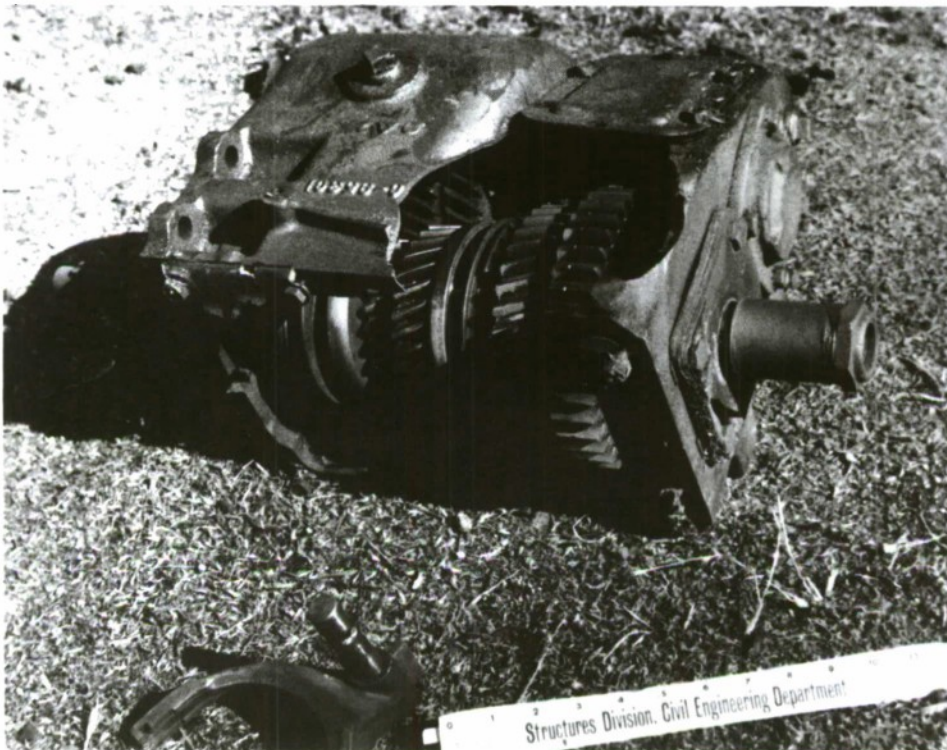
Figure 32. Postshot view of transmission, part Z.

Several preshot and postshot photographs show the severity of the breakup of the parts (Figures 29 through 32). Several of the items found at large distances from the charge include: a piece of aluminum manifold (A34) at 250 feet, a steel gear (C20) at 219 feet, and a piece of chain (C27) at 302 feet.

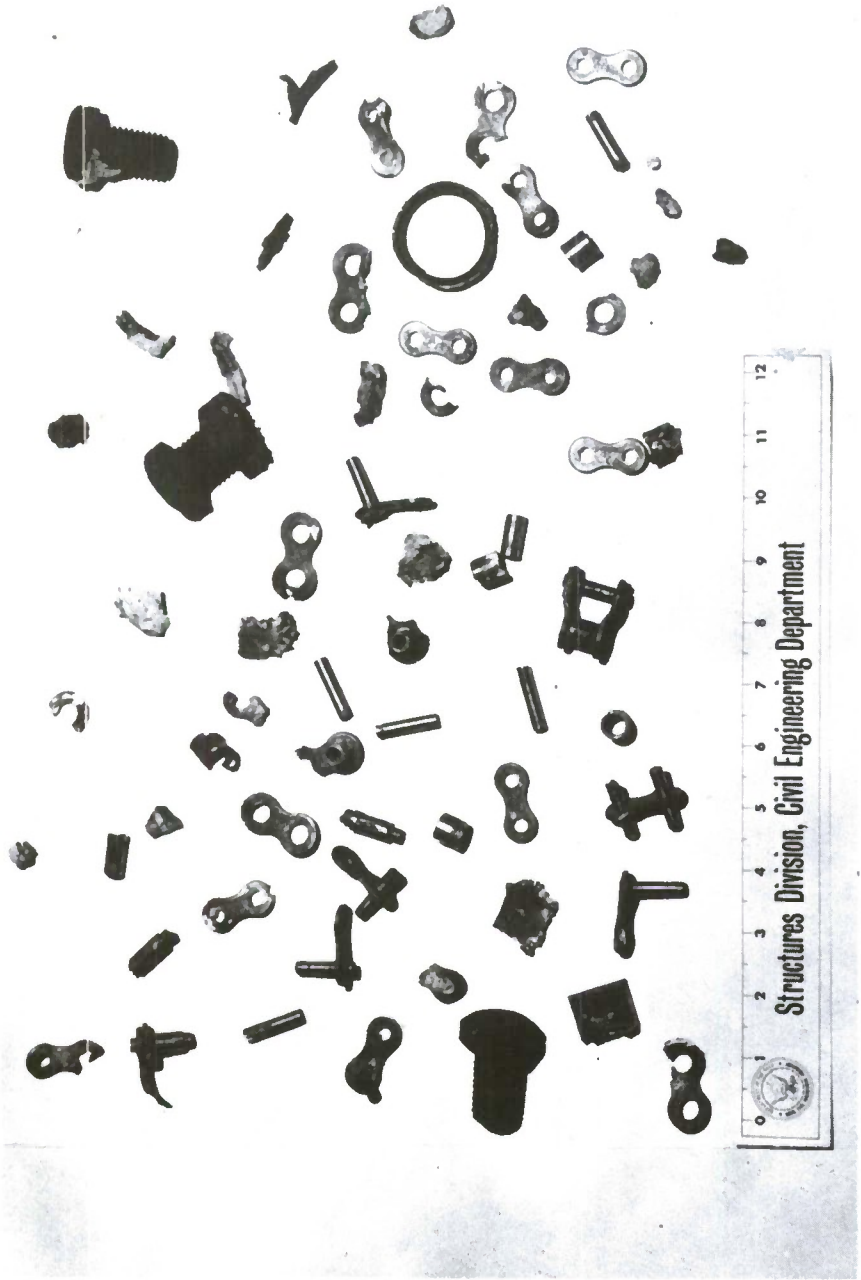
Figure 35. Small fragments that struck backstops.

The wallboard used in this test was NU-WOOD STA-LITE white interior finish cellulose-fiber insulation board manufactured by the Conwed Corporation. After each shot, an attempt was made to identify items which impacted on the backstop and rebounded without penetration. The fragment damage is shown in Figure 33. After the shots, the backstops were returned to the laboratory, where the fragments were recovered and weighed. The penetration, angle of entry, and area of entry were measured. Typical fragments are shown in Figures 34 and 35. The velocities of the fragments are presented in Table 8.

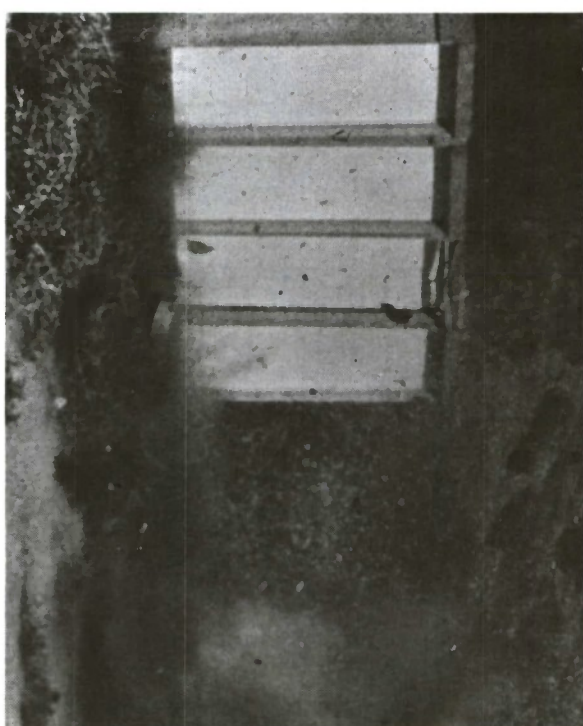
Note: Total coverage  $\approx 0.65$  sec.

Figure 36. High-speed photographs of fragments.
